Success Through Collaboration: Case Type I

Cappy Sinclair, DDS, AAACD

Key Words: gingival esthetics, lab communication, porcelain veneers, smile design, Accreditation Case Type I

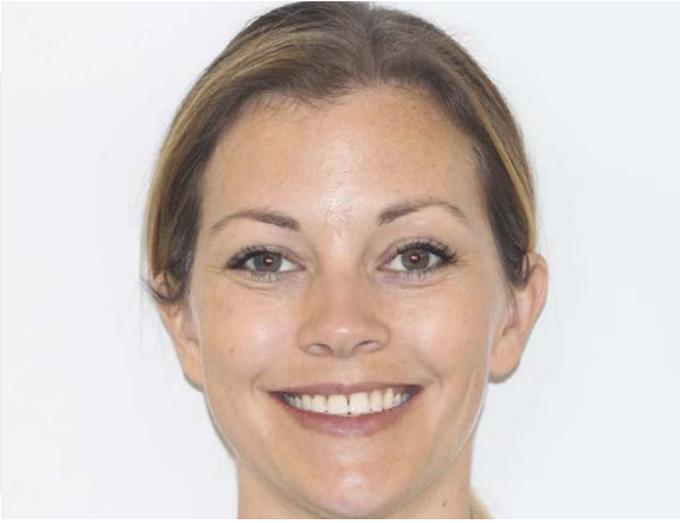
Figure 1: Preoperative full-face view (1:10).

The patient presented seeking an overall change in her smile (Fig 1). She had previous bonding that was starting to show signs of age, and orthodontic positioning of the teeth during adolescence had created black triangles due to the coronal placement of the contact points. She was getting married in six months and wanted a beautiful smile for her wedding photos.

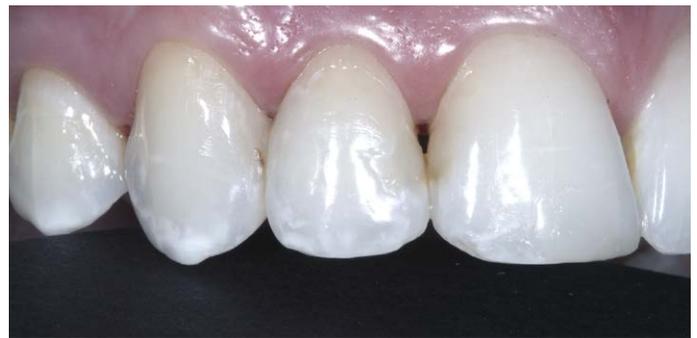
The major problems with the patient's smile included the tooth shape discrepancy and black triangles associated with her anterior teeth due to prior orthodontic treatment (Figs 2 & 3). The orthodontic treatment had also led to white spot lesions, and bonding had been placed in various areas to mask them. Knowing that we wanted to change the size of her teeth and shape of her smile, it was determined that 10 indirect porcelain restorations would be fabricated to create harmony and establish symmetry in the smile. Diagnostic impressions would be taken, and a diagnostic wax-up would be performed. The diagnostic wax-up would serve as a blueprint of the patient's desires so that we could minimize the amount of enamel that had to be removed.¹ Our goal was to improve the smile by eliminating the black triangles with 10 porcelain restorations as well as developing the buccal corridor (Fig 4).

Figure 2: Right lateral retracted view (1:1) showing black triangles that concerned the patient.

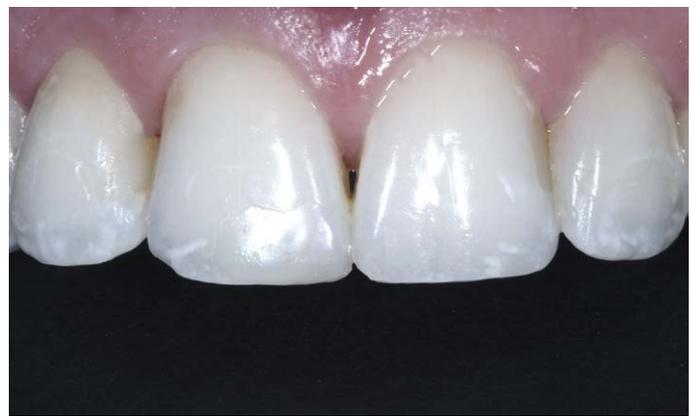
Figure 3: Frontal retracted view (1:1); prior composite bonding placed to mask decalcifications.

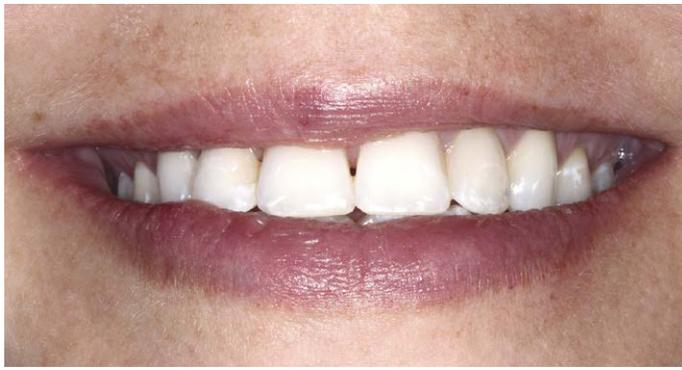
Figure 4: Full-smile frontal view (1:2) showing a wide smile with an extensive buccal corridor.

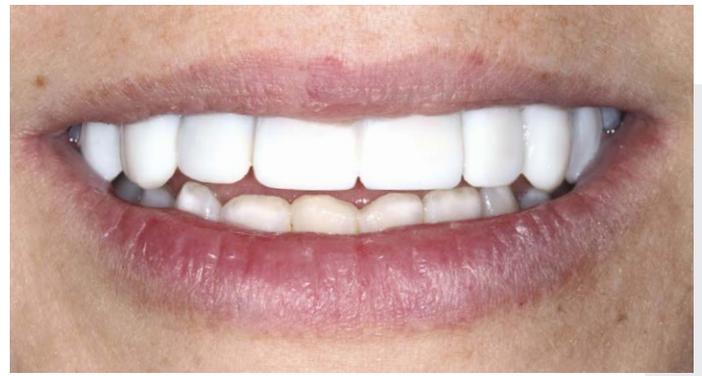
Figure 5: Full-smile frontal view (1:2); provisionals showing very square tooth forms.

Modifications: At the next visit, there were several changes that the patient desired to see in the final restorations (Fig 5). These included more surface texture and for the incisal embrasures to be a more rounded shape. These modifications were

made in the provisionals, and the patient approved them. Finally, she requested that the final restorations be more chromatic than the provisionals. Once the patient approved the provisionals' size, shape, and color, a PVS (3M) impression of the temporaries was taken along with a facebow (Whip Mix; Louisville, KY), and the AACD series of photos were taken for communication with the technician. The patient was asked to return for try-in and delivery of the final restorations.

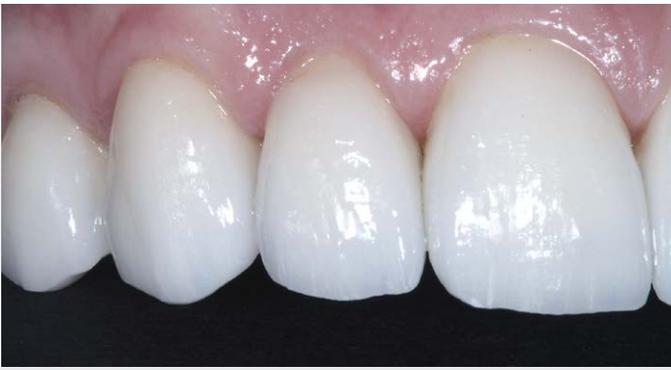
Figure 6: Postoperative retracted right lateral view (1:1) showing that tissue fill-in still needed to occur.

Final follow-up: The patient returned 72 hours later to check the occlusion as well as tissue healing. The papillae had returned to better positions, but black triangles remained (Figs 6 & 7). However, since the contact positions were placed 4 mm from the crest of the bone interproximally, we believed that the tissue would mature into the proper position in just a few weeks.⁵ This is evident from the final photos taken six weeks after delivery (Figs 8 & 9). Ultimately, the patient had a much-improved smile overall, with the expanded buccal corridor and the natural transitions in shade (Figs 10 & 11).

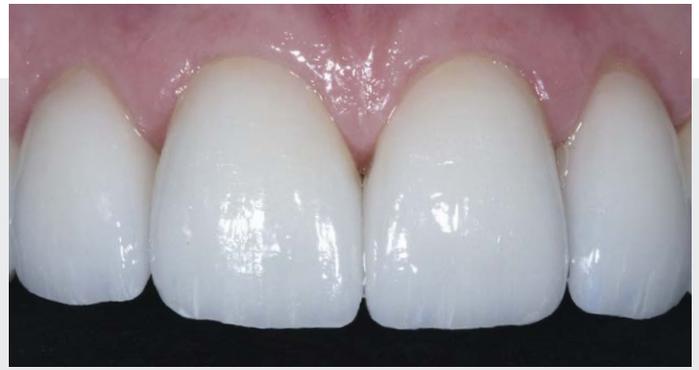
Figure 7: Postoperative retracted frontal view (1:1); healing of the tissue after 72 hours still showed black triangles.

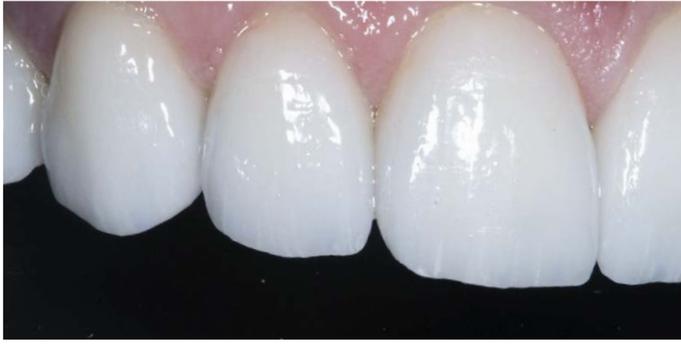
Figure 8: Postoperative retracted right lateral view (1:1); final healing of the gingival tissues showing closure of black triangles.

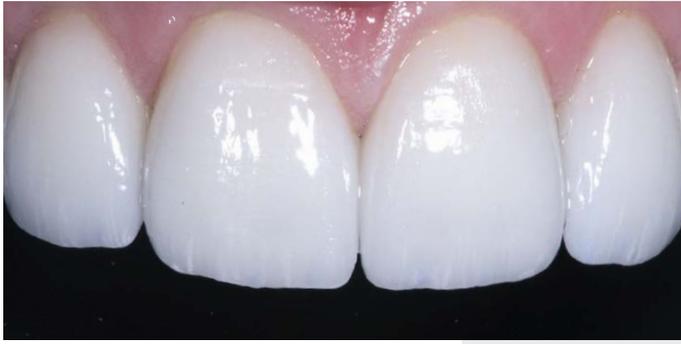
Figure 9: Postoperative retracted frontal view (1:1); final healing of the gingival tissues showing closure of black triangles.

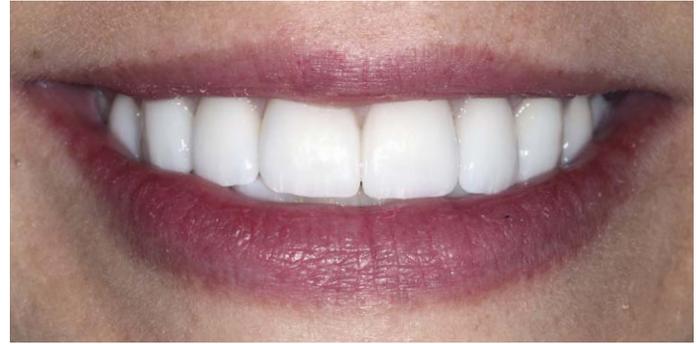
Figure 10: Postoperative frontal view (1:2); final smile with filled out buccal corridor.

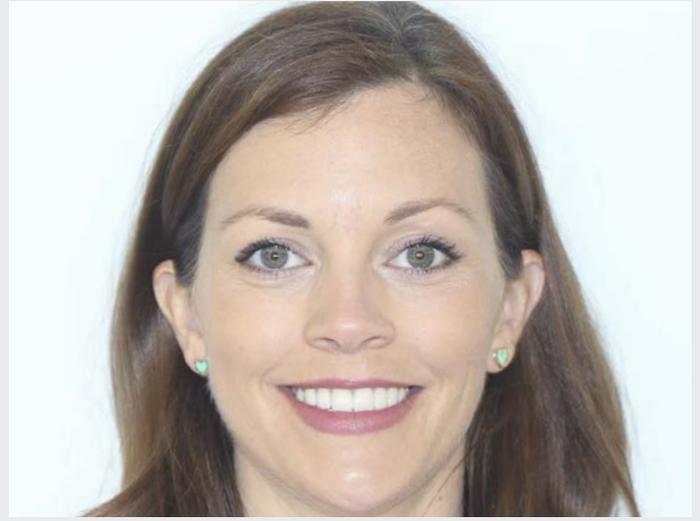
Figure 11: Postoperative final full-face portrait view (1:10).
